**PROJECT: Sycamore Avenue Trunk Sewer Replacement Project**

**TRUNK SEWER REPAIR AND CAPACITY PLAN**

**SYCAMORE AVENUE TRUNK SEWER REPLACEMENT PROJECT SHEET**

**WEST YOST  
ASSOCIATES**

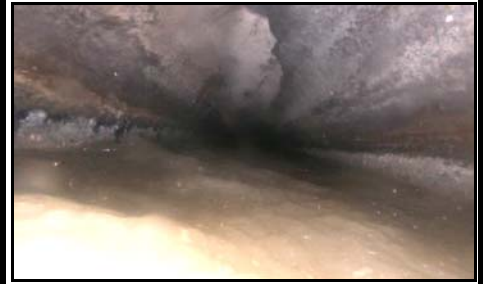
MH 2 to Vault 1 at 0 feet - Corrosion and grease, typical throughout project area.

| PPS CCTV Inspection, 7/20/16 - 07/21/16 | | | | | | | | | City of Hercules GIS | | | West Yost Assessment | |
|---|---|---|---|---|---|---|---|---|---|---|---|---|---|
| MH 2 | VAULT 1 | 24 | 231.8 | 213 | RCP | 5JOO | 0 | 5JOO | - | - | - | Surface corrosion throughout, water level 40% (to 25%), minor cracks, no signs of spot repair. | 6.01 |

**Recommendations:** Replace existing 20" and 24" trunk sewer with 27" PVC sewer and install new manholes. Bridge crossing over Pinole Creek and bore and jack under railroad, both near the corners of Railroad and Tennent Ave., just upstream of the WPCP.

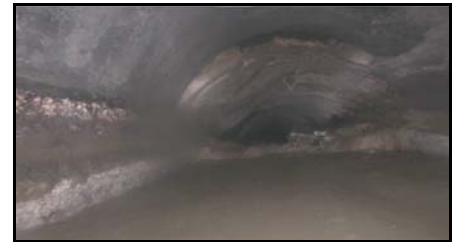
Vault 8 to Vault 7 at 270 feet – Grease/blockage in flow and corrosion/spalling from 9 to 3 o'clock.

| PPS CCTV Inspection, 7/20/16 - 07/21/16 | | | | | | | | | City of Hercules GIS | | | West Yost Assessment | |
|---|---|---|---|---|---|---|---|---|---|---|---|---|---|
| VAULT 8 | VAULT 7 | 24 | 272.7 | 328 | RCP | 5J3F | 5126 | 5J3F | - | - | 24 | Surface corrosion throughout, water level 40% to 70%, deposits attached, sag 160-215 ft, obstruction in joint to abandonment, neither Exhibit A observation seen at 240 ft or 270 ft. | 6.17 |
