# Wetland Delineation Preliminary Jurisdictional Determination

## Wetland Delineation and Preliminary Jurisdiction Waters Determination

Hercules Hotel Development LLC  
1365 Murchison Drive  
Millbrae, CA 94030

February 4, 2020

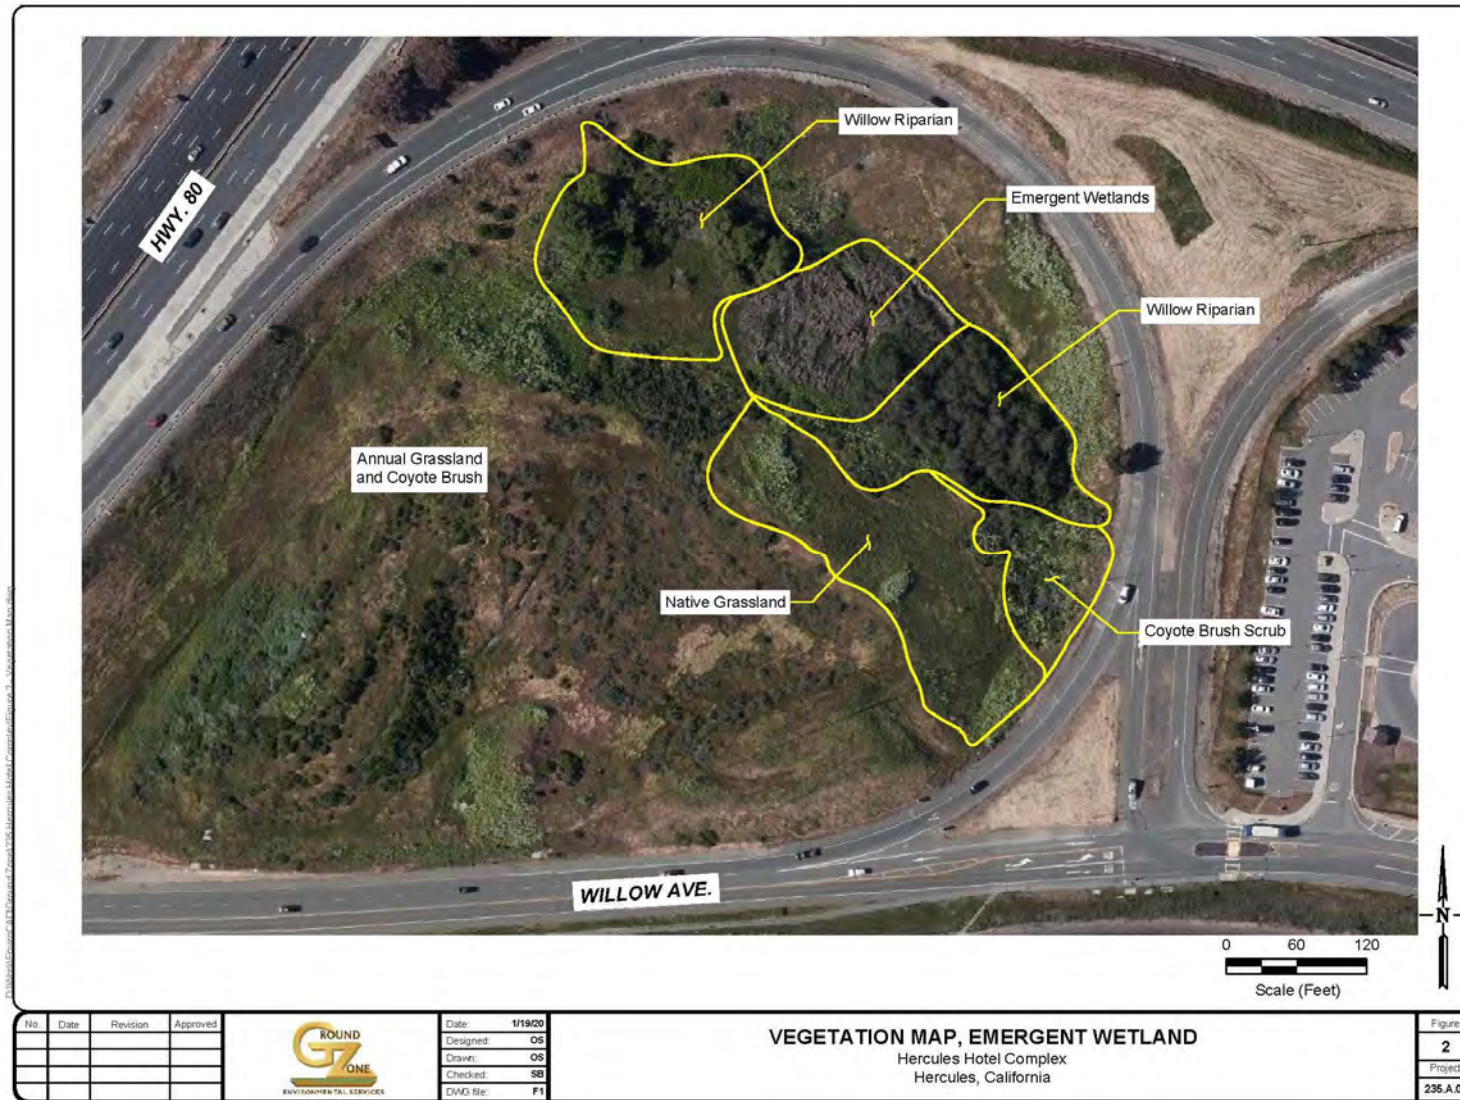
**Figure 5** Vegetative Communities

Non-native Annual Grassland. As a result of disturbance and undocumented soil deposition activities on the site, much of the vegetative cover (observed December 16, 2019) contained areas of non-native annual grassland with species including ripgut brome (*Bromus diandrus*), wild-oat (*Avena fatua*), annual fescue (*Vulpia myuros*) intergrading with disturbed areas, dominated by other introduced weedy forbs such as black mustard (*Brassica nigra*), wild radish (*Raphanus sativus*), and perennial pepperweed (*Lepidium latifolium*). During observations on December 16, 2019, these grasslands were seen to have been graded and seeded with what was assumed to be erosion control grass seed mix.

Native Grassland. Portions of the Site have vegetative cover almost exclusively consisting of native creeping wild-rye (*Leymus triticoides*), a rhizomatous species that spreads through expansion of the plants by its spreading roots. On the Project site, in most areas where wild-rye was seen growing, there were no other plant species observed. Native creeping wild-rye usually grows under moist soil conditions, and appeared to be located preferentially on the cooler north facing slopes of the site.

Emergent wetland (cattail marsh). Within the northern portion of the site, adjacent the unnamed tributary of Refugio Creek, elevations are low, forming a basin that includes open water (during years of higher rainfall) grading into freshwater cattail marsh wetlands dominated by non-native plants, including: narrow-leaf cattail (*typha angustifolia*) and wild teasel (*dipsacus fullonum*) at the margins.

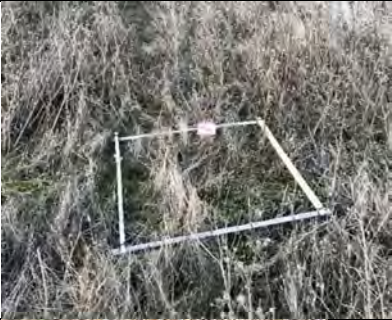
| Wetland Delineation Plant Survey | | | | | |
|---|---|---|---|---|---|
| 1 | <i>Elymus triticoides</i> (50%) | Creeping wild rye | native | UPL | |
| | <i>Dipsacus fullonum</i> (20%) | Wild teasel | Non-native | FAC | |
| | <i>Conium maculatum</i> (5%) | poison hemlock | Non-native | FACW/FAC | |

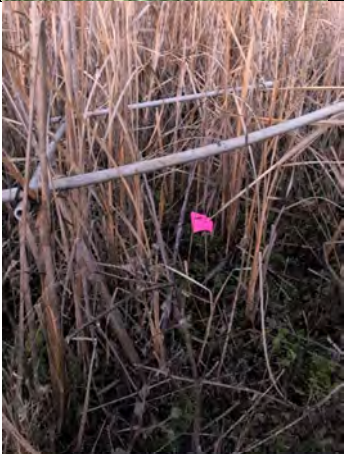
| Wetland Delineation Plant Survey | | | | | |
|---|---|---|---|---|---|
| 3 | <i>Typha angustifolia</i> (80%) | Narrow-leaved Cattail | Non-native | OBL | |
| | <i>Dipsacus fullonum</i> (10%) | wild teasel | Non-native | FAC | |
| | <i>Conium maculatum</i> (10%) | Poison hemlock | Non-native | FACW/FAC | |

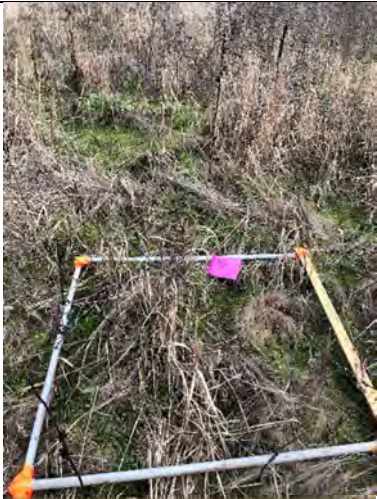
| 4 | <i>Elymus triticoides</i><br>(50%) | Creeping wild<br>rye | native | UPL | | |

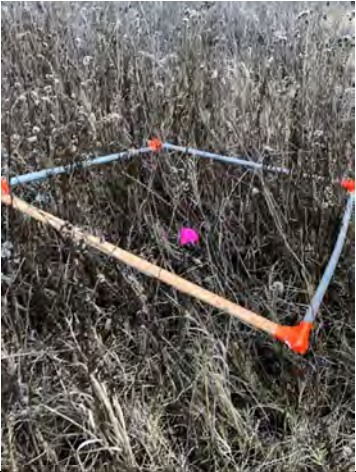
| 5 | <i>Baccharis glutinosa</i><br>(60%) | Marsh<br>Baccharis | Native | FACW/OBL | | |

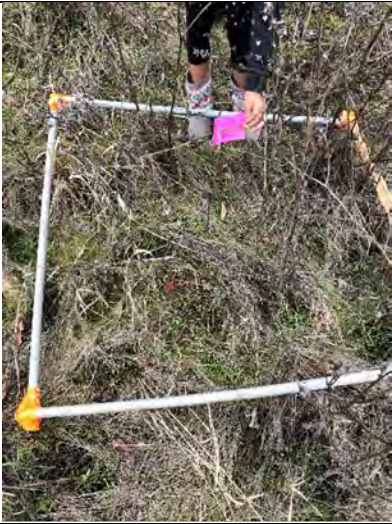
| 6 | <i>Elymus triticoides</i><br>(15%) | Creeping wild<br>rye | native | UPL | |

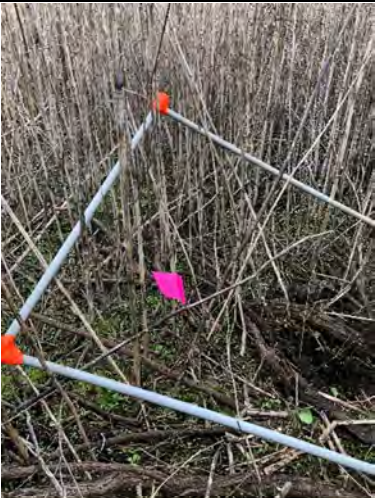
| 7 | <i>Raphanus sativus</i><br>(20%) | Wild radish | Non-native | UPL | |
| | <i>Conium maculatum</i><br>(50%) | Poison<br>hemlock | Non-native | FACW/FAC | |

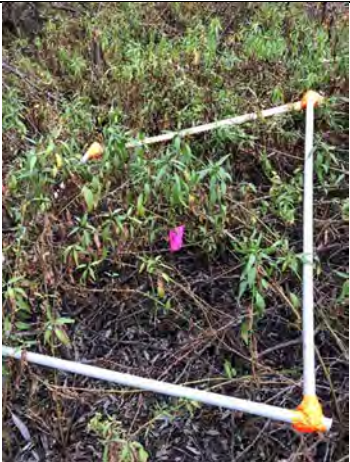
| 8 | <i>Baccharis glutinosa</i><br>(80%) | Marsh Baccharis | Native | FACW/OBL | | |
| | <i>Salix lasiolepis</i><br>(85%) | Arroyo willow | Native | FACW | | |

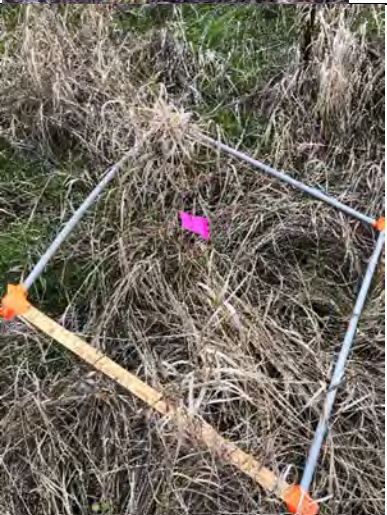
| 9 | <i>Elymus triticoides</i><br>(100%) | Creeping wild rye | Native | UPL | | |

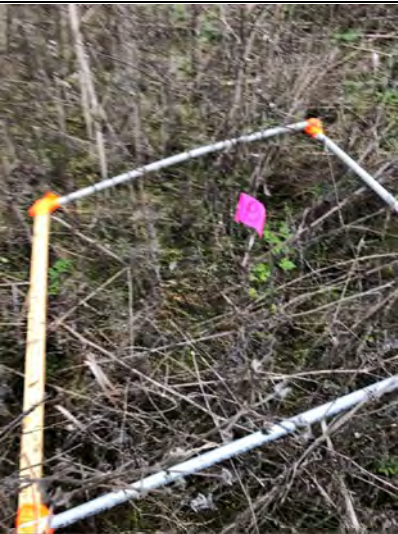
| 10 | <i>Conium maculatum</i><br>(40%) | Poison hemlock | Non-native | FACW/FAC | | |
| | <i>Dipsacus fullonum</i><br>(10%) | wild teasel | Non-native | FAC | | |

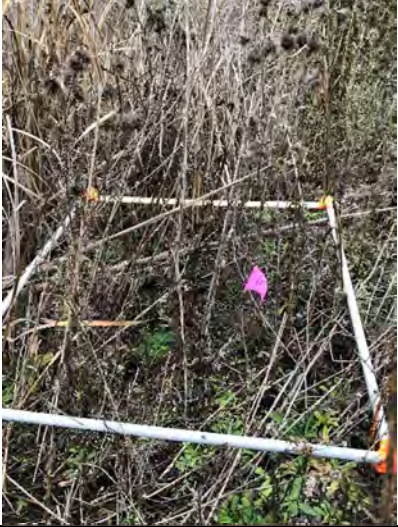
| 11 | <i>Dipsacus fullonum</i><br>(30%) | wild teasel | Non-native | FAC | | |
| | <i>Cirsium vulgare</i><br>(60%) | Bull Thistle | Non-native | FACU | | |

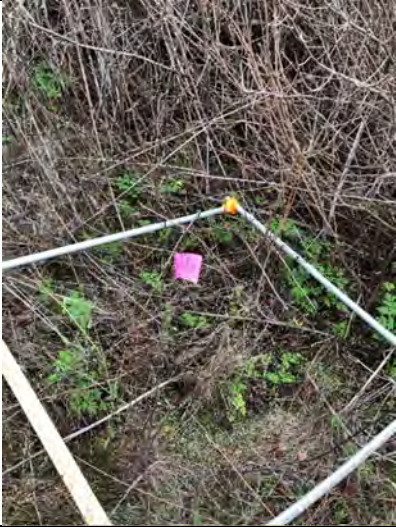
| 12 | <i>Conium maculatum</i><br>(20%) | poison hemlock | Non-native | FACW/FAC | |
| | <i>Salix lasiolepis</i><br>(10%) | Arroyo willow | Native | FACW | |

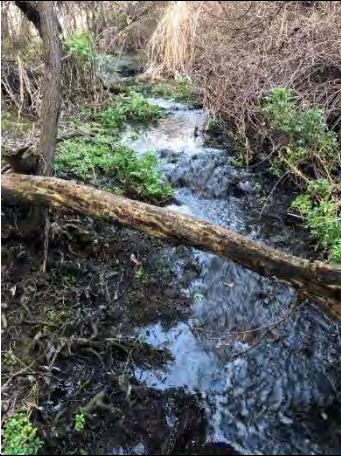
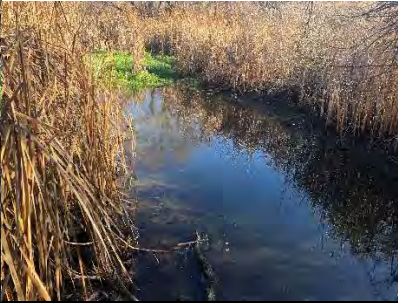
| Open Water Creek | <i>Nasturtium officinale</i> | Water cress | Native | OBL | |
| | <i>Salix lasiolepis</i> | Arroyo willow | Native | FACW | |
| | <i>Typha angustifolia</i><br>(80%) | Narrow-leaved Cattail | Non-native | OBL | |
