**1444 WILLOW AVE**  
HERCULES, CALIFORNIA

## **PRELIMINARY GEOTECHNICAL EXPLORATION**

**PREPARED BY**  
ENGEO Incorporated

November 16, 2017

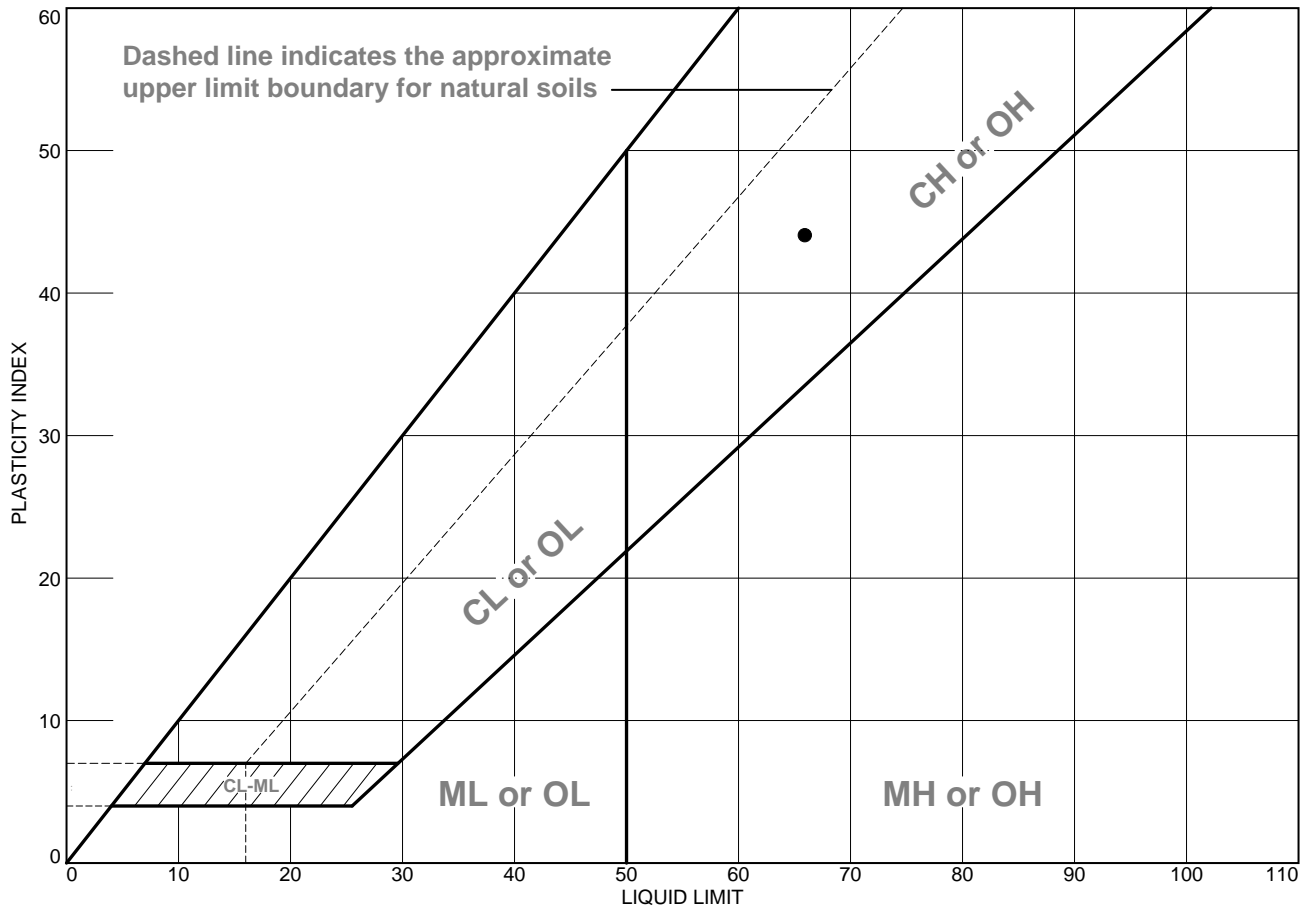
# LIQUID AND PLASTIC LIMITS TEST REPORT

MATERIAL DESCRIPTION	LL	PL	PI	%<#40	%<#200	USCS
●	See exploration logs	66	22	44	100.0	99.5	CH

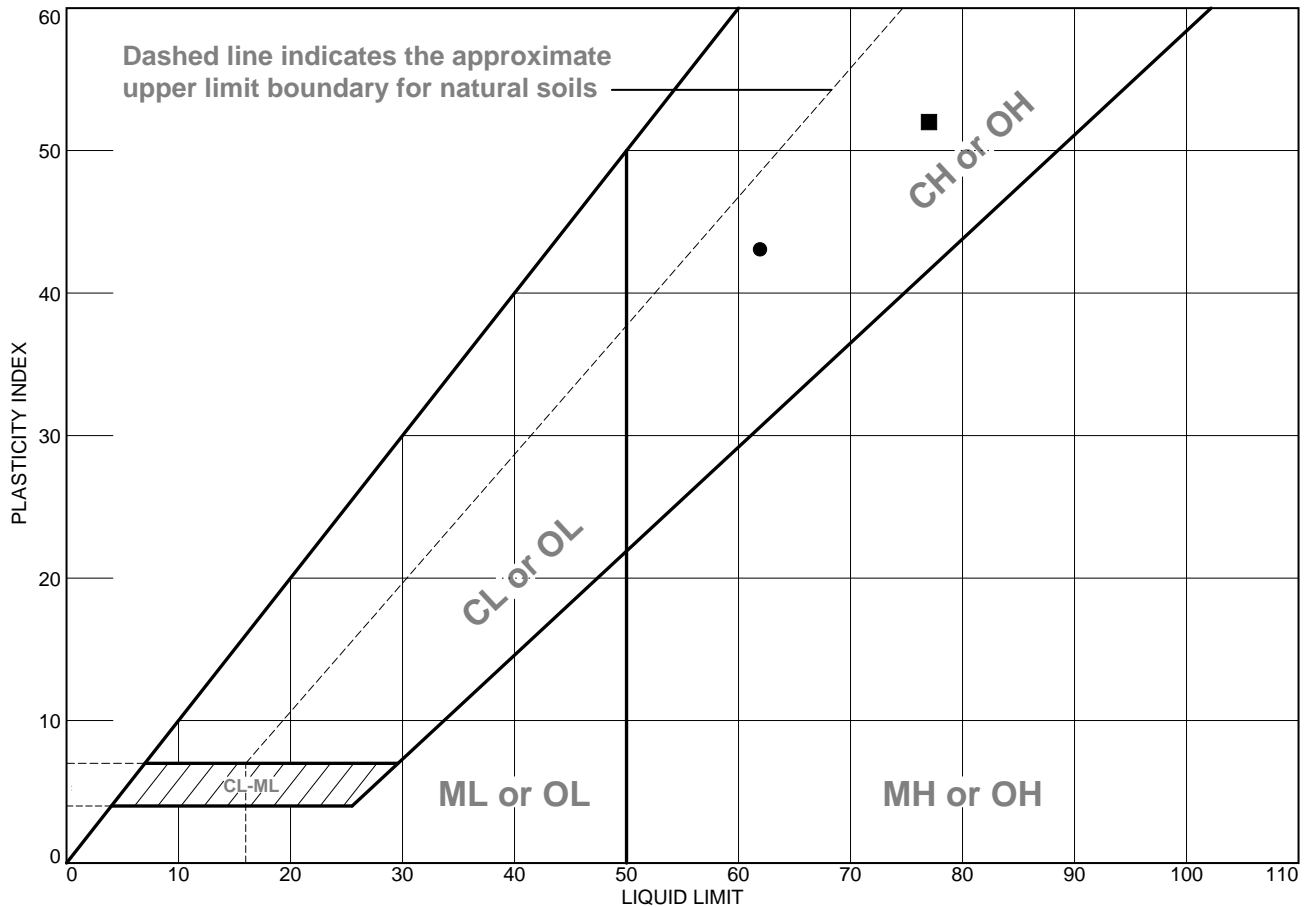
# LIQUID AND PLASTIC LIMITS TEST REPORT

MATERIAL DESCRIPTION	LL	PL	PI	%<#40	%<#200	USCS
●	See exploration logs	62	19	43	100.0	98.5	CH
■	See exploration logs	77	25	52	92.0	89.3	CH

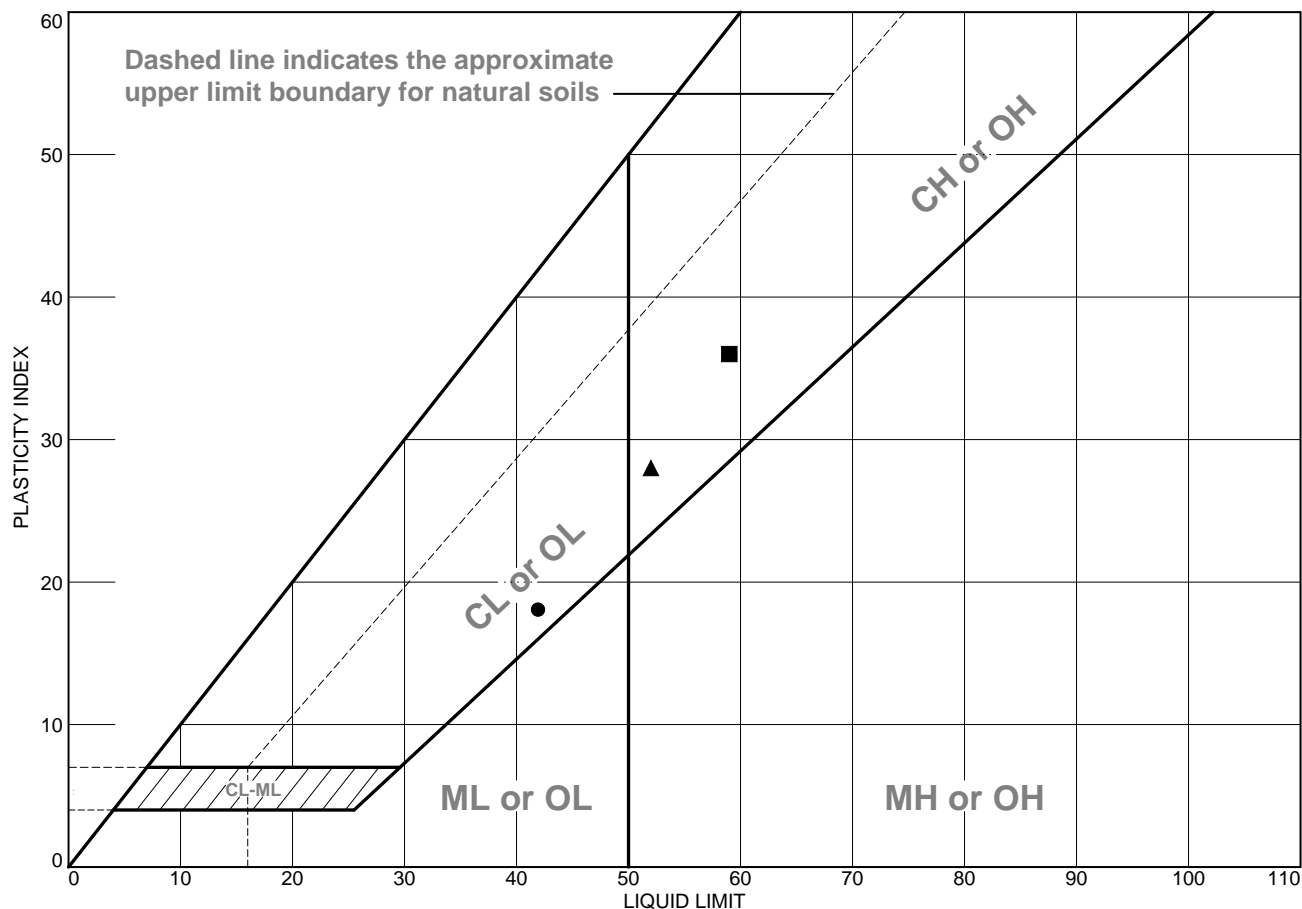
# LIQUID AND PLASTIC LIMITS TEST REPORT

MATERIAL DESCRIPTION	LL	PL	PI	%<#40	%<#200	USCS
●	See exploration logs	42	24	18	92.4	88.8	CL
■	See exploration logs	59	23	36	91.7	87.6	CH
▲	See exploration logs	52	24	28	92.9	78.7	CH

Bedrock within the site consists of a highly weathered gray shale. The rock is weak to medium strong and closely to very closely fractured. Iron oxide staining was observed in the exposed bedrock, with possible iron-hydroxide deposits observed in test pits 1-TP7 and 1-TP8. Fractures observed in the test pits tended to strike northeast with shallow to moderate dips to west. Bedding measured in test pits 1-TP1 and 1-TP6 strikes northwest and dips moderately to the east. Bedrock was not observed in test pits 1-TP3 and 1-TP4. The bedrock on site appears to have plasticity ranging from low to high (PI = 18 to 52).

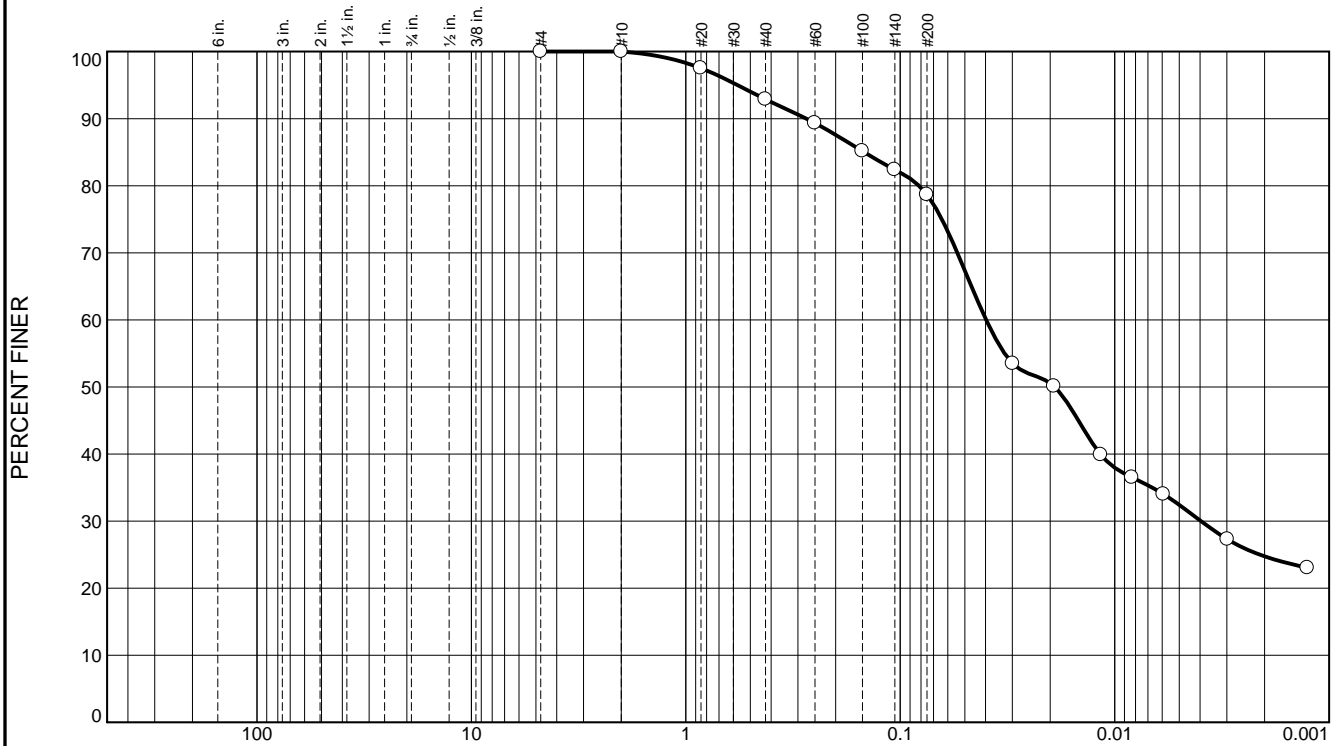
# Particle Size Distribution Report

% +75mm	% Gravel		% Sand			% Fines	
	Coarse	Fine	Coarse	Medium	Fine	Silt	Clay
0.0	0.0	0.0	0.0	7.1	14.2	54.0	24.7

SIEVE SIZE	PERCENT FINER	SPEC.* PERCENT	PASS? (X=NO)
#4	100.0		
#10	100.0		
#20	97.5		
#40	92.9		
#60	89.3		
#100	85.2		
#140	82.4		
#200	78.7		
0.0298 mm.	53.5		
0.0192 mm.	50.1		
0.0116 mm.	39.9		
0.0083 mm.	36.5		
0.0059 mm.	34.0		
0.0030 mm.	27.3		
0.0013 mm.	23.0

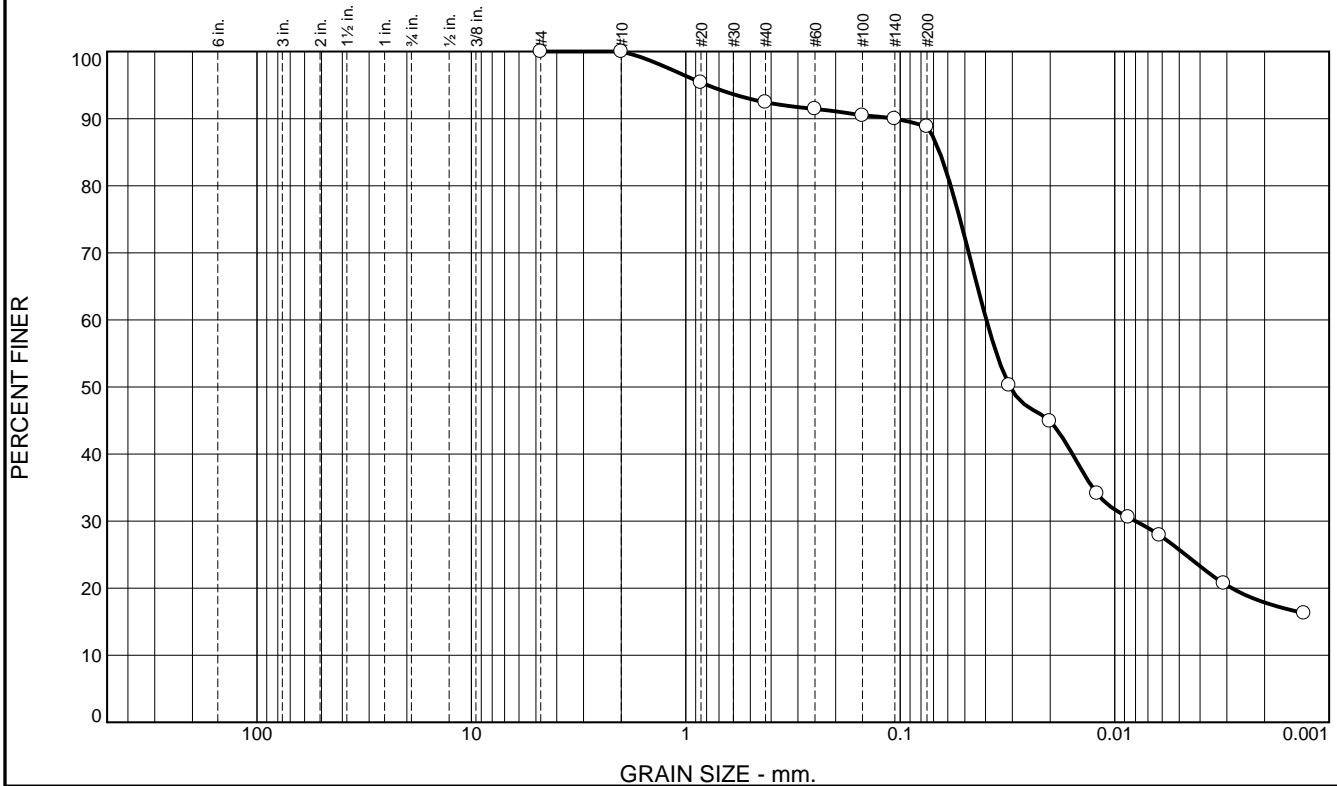
# Particle Size Distribution Report

% +75mm	% Gravel		% Sand			% Fines	
	Coarse	Fine	Coarse	Medium	Fine	Silt	Clay
0.0	0.0	0.0	0.0	7.6	3.6	70.9	17.9

SIEVE SIZE	PERCENT FINER	SPEC.* PERCENT	PASS? (X=NO)
#4	100.0		
#10	100.0		
#20	95.4		
#40	92.4		
#60	91.4		
#100	90.5		
#140	90.0		
#200	88.8		
0.0310 mm.	50.3		
0.0201 mm.	44.9		
0.0121 mm.	34.1		
0.0086 mm.	30.6		
0.0062 mm.	27.9		
0.0031 mm.	20.7		
0.0013 mm.	16.3

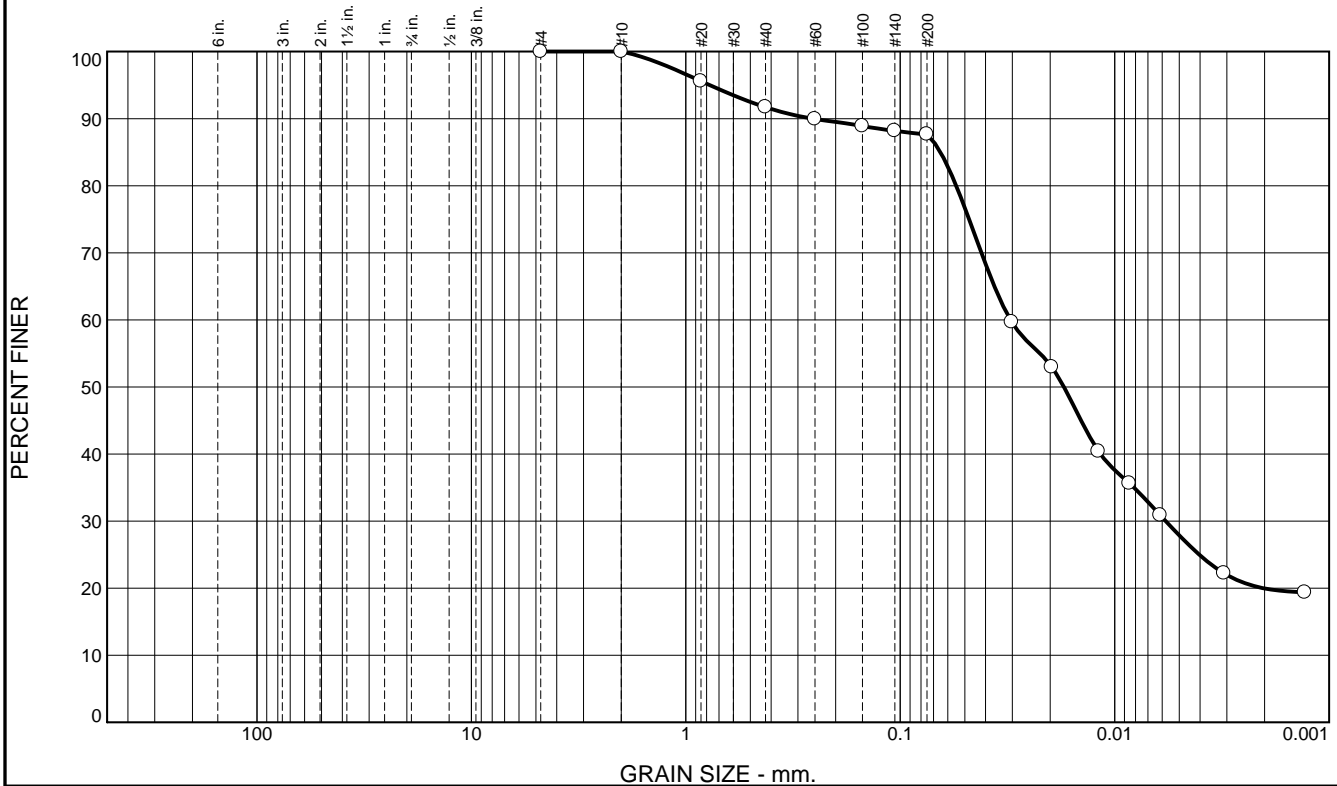
# Particle Size Distribution Report

% +75mm	% Gravel		% Sand			% Fines	
	Coarse	Fine	Coarse	Medium	Fine	Silt	Clay
0.0	0.0	0.0	0.0	8.3	4.1	67.6	20.0

SIEVE SIZE	PERCENT FINER	SPEC.* PERCENT	PASS? (X=NO)
#4	100.0		
#10	100.0		
#20	95.6		
#40	91.7		
#60	89.9		
#100	88.9		
#140	88.2		
#200	87.6		
0.0302 mm.	59.7		
0.0196 mm.	52.9		
0.0119 mm.	40.4		
0.0085 mm.	35.6		
0.0061 mm.	30.9		
0.0031 mm.	22.2		
0.0013 mm.	19.4

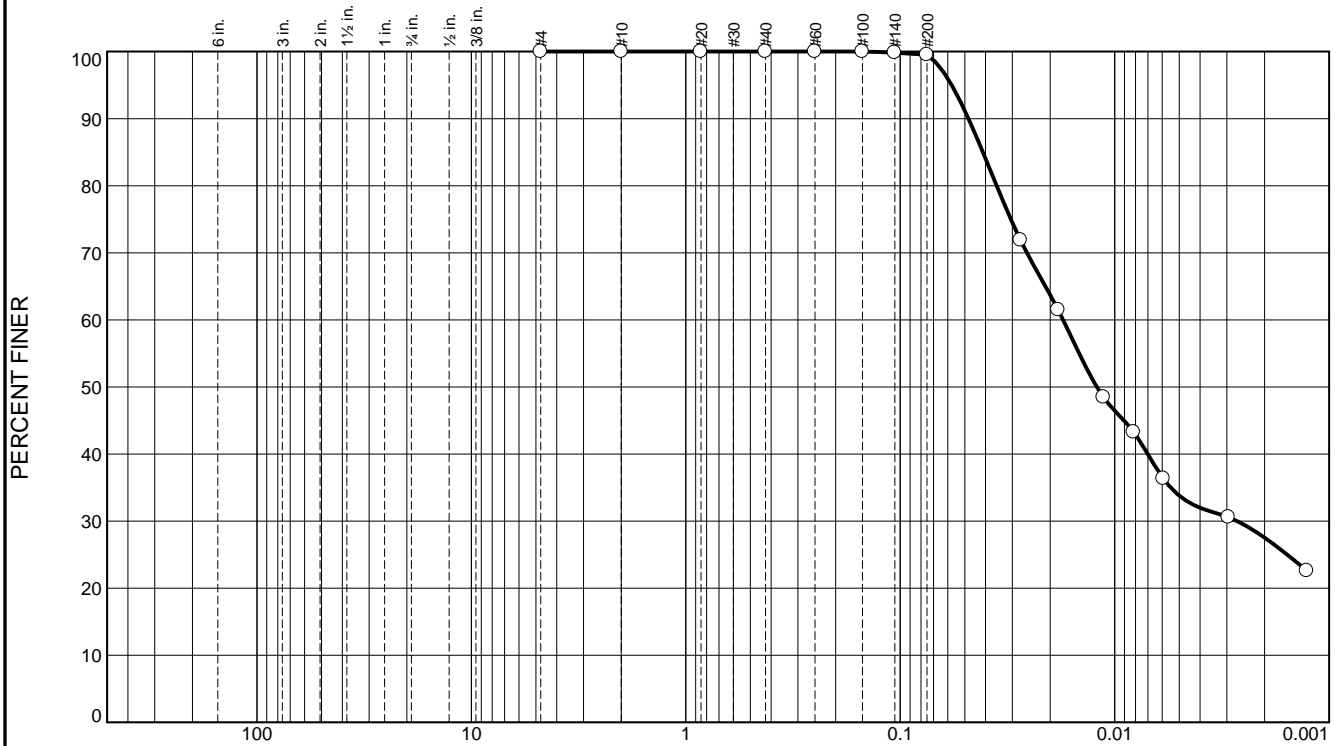
# Particle Size Distribution Report

% +75mm	% Gravel		% Sand			% Fines	
	Coarse	Fine	Coarse	Medium	Fine	Silt	Clay
0.0	0.0	0.0	0.0	0.0	0.5	72.0	27.5

SIEVE SIZE	PERCENT FINER	SPEC.* PERCENT	PASS? (X=NO)
#4	100.0		
#10	100.0		
#20	100.0		
#40	100.0		
#60	100.0		
#100	100.0		
#140	99.8		
#200	99.5		
0.0275 mm.	71.9		
0.0184 mm.	61.5		
0.0113 mm.	48.5		
0.0081 mm.	43.3		
0.0059 mm.	36.3		
0.0029 mm.	30.6		
0.0013 mm.	22.6

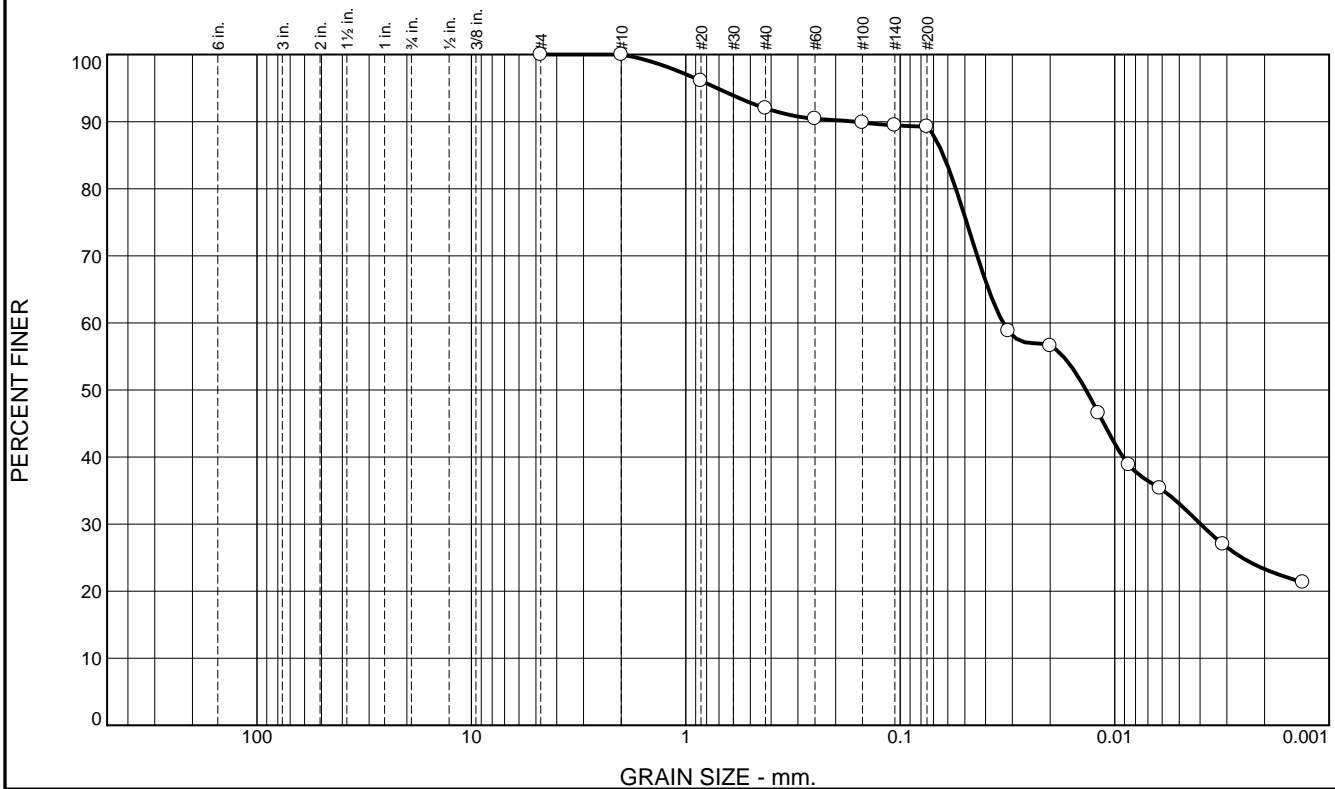
# Particle Size Distribution Report

% +75mm	% Gravel		% Sand			% Fines	
	Coarse	Fine	Coarse	Medium	Fine	Silt	Clay
0.0	0.0	0.0	0.0	8.0	2.7	66.0	23.3

SIEVE SIZE	PERCENT FINER	SPEC.* PERCENT	PASS? (X=NO)
#4	100.0		
#10	100.0		
#20	96.1		
#40	92.0		
#60	90.4		
#100	89.8		
#140	89.5		
#200	89.3		
0.0314 mm.	58.8		
0.0200 mm.	56.6		
0.0119 mm.	46.5		
0.0086 mm.	38.9		
0.0062 mm.	35.4		
0.0031 mm.	27.0		
0.0013 mm.	21.3

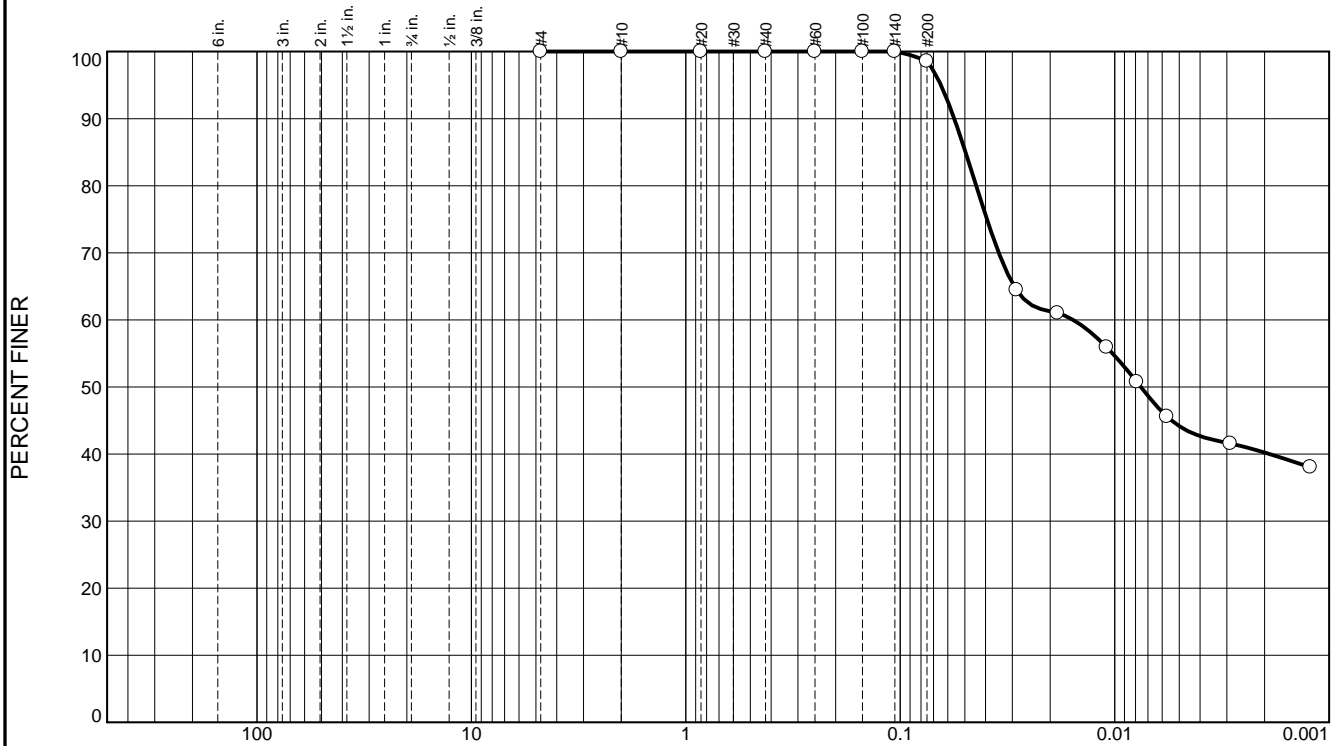
# Particle Size Distribution Report

% +75mm	% Gravel		% Sand			% Fines	
	Coarse	Fine	Coarse	Medium	Fine	Silt	Clay
0.0	0.0	0.0	0.0	0.0	1.5	58.3	40.2

SIEVE SIZE	PERCENT FINER	SPEC.* PERCENT	PASS? (X=NO)
#4	100.0		
#10	100.0		
#20	100.0		
#40	100.0		
#60	100.0		
#100	100.0		
#140	100.0		
#200	98.5		
0.0287 mm.	64.4		
0.0184 mm.	61.0		
0.0109 mm.	55.9		
0.0079 mm.	50.7		
0.0057 mm.	45.6		
0.0029 mm.	41.6		
0.0012 mm.	38.0
