## **Appendix E: Phase I Environmental Site Assessment**

**PHASE I  
ENVIRONMENTAL SITE ASSESSMENT  
OF  
1444 WILLOW AVENUE  
APN 406-522-001 & 406-522-004  
CONTRA COSTA COUNTY  
IN  
HERCULES, CALIFORNIA**

**August 8, 2016**

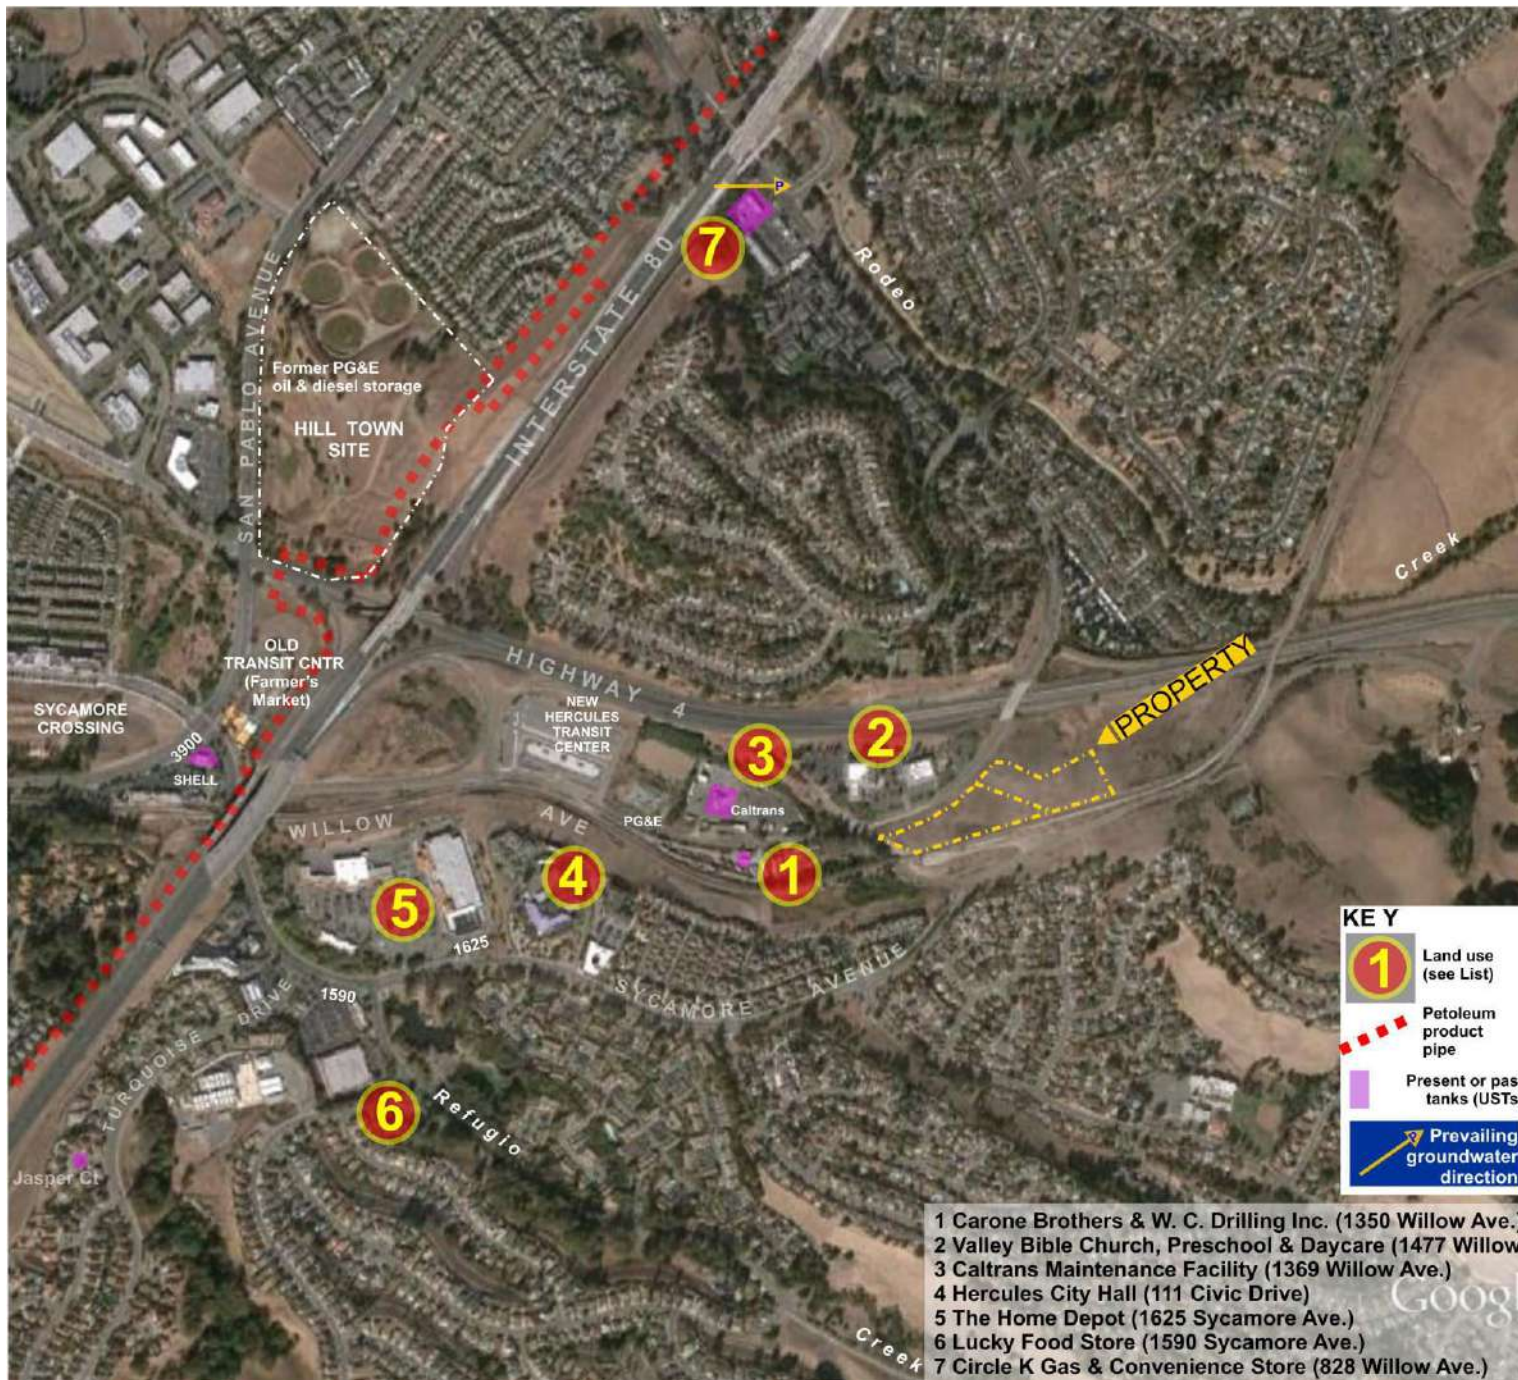
**Figure 2**  
 Neighborhood Map  
 1444 Willow Avenue  
 Hercules, California

Figure 2 illustrates the locations of Carone Brothers lot (1350 Willow Avenue), Caltrans Maintenance Facility (1369 Willow Avenue), BP service station (828 Willow Avenue) and the Old Transit Center (Sycamore Avenue at San Pablo Avenue). In view of the locations of the releases, these LUST sites, with the possible exception of the past release at Carone Bros., do not pose an obvious likelihood or an apparent risk of environmental impairment for the owner of the Property.

Service stations and dry cleaners do not adjoin the Property. The nearest past or current service station, Union 76 (also, formerly known as BP/Circle K, TOSCO or Conoco Phillips), is located at least 3,500 feet north-northwest of the Property. See Figure 2. The nearest dry cleaners handling dry cleaning fluid called PERC, or formerly handling PERC, are Willow Cleaners (844 Willow Avenue #A5), Hercules Cleaners (1581 Sycamore Avenue #7), Park Lane Cleaners (1572 Sycamore Avenue #C), and Creekside Cleaners (1511 Sycamore Avenue #G). See Figure 2.

The nearest petroleum storage tanks, which were used for storing gasoline and diesel fuel, were located at the Caltrans Maintenance Facility (1369 Willow Avenue, formerly Bayberry Avenue) and at the Carone Brothers Inc. lot (1350 Willow Avenue, formerly Bayberry Avenue). Figure 2 illustrates the locations of Carone Brothers lot (1350 Willow Avenue) and Caltrans Maintenance Facility (1369 Willow Avenue). In view of the analysis provided in Section 5.3 and

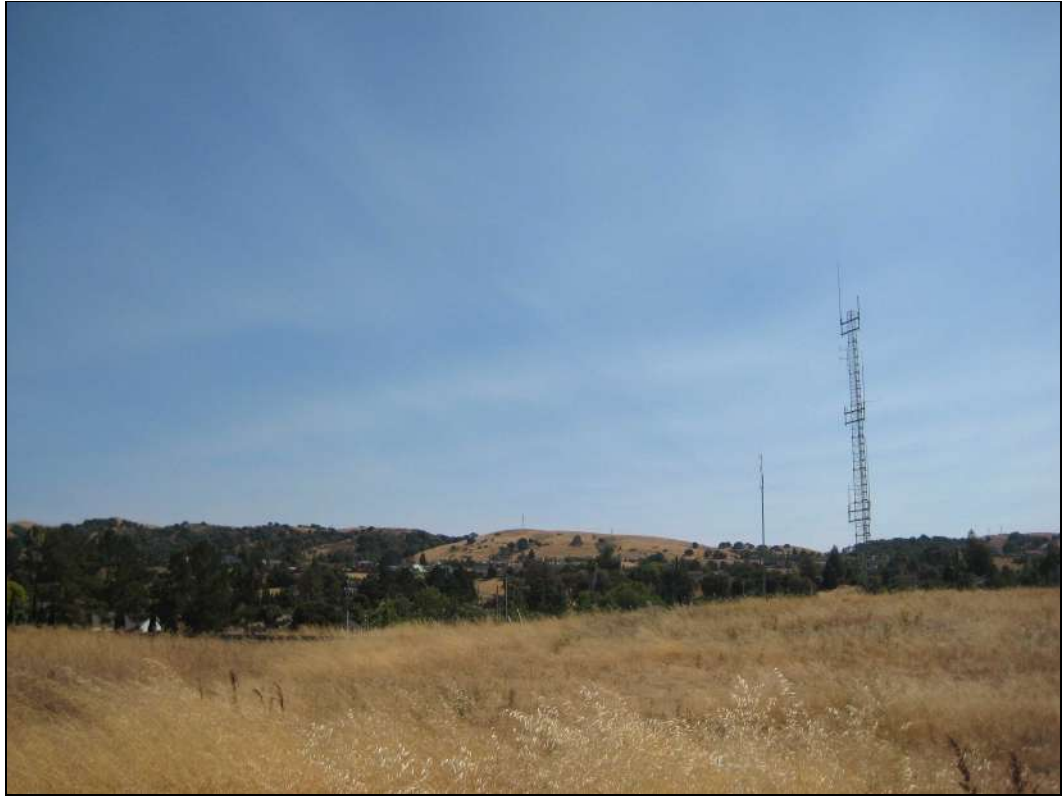
**Plate 1. View from Willow Avenue Looking South across the Property in Hercules, California (July 27, 2016)**

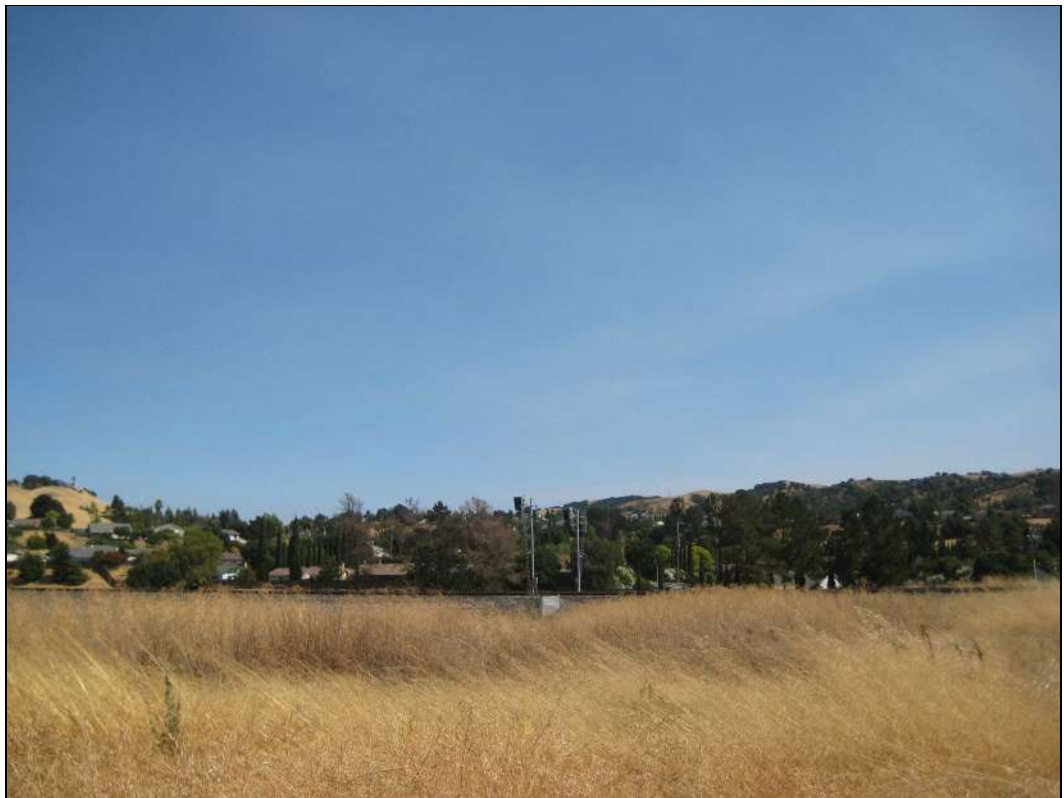
**Plate 2. View from Willow Avenue Looking South across the Property in Hercules, California (July 27, 2016)**

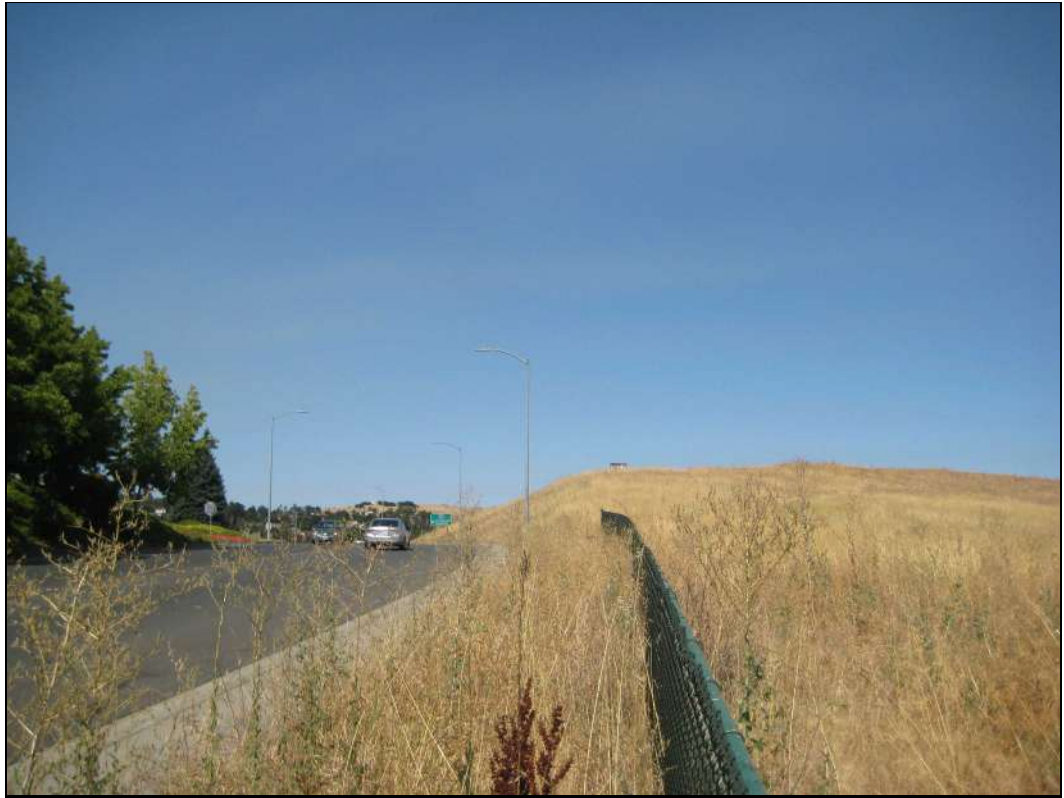
**Plate 3. View along Willow Avenue Looking East along the Northern Side of the Property in Hercules, California (July 27, 2016)**

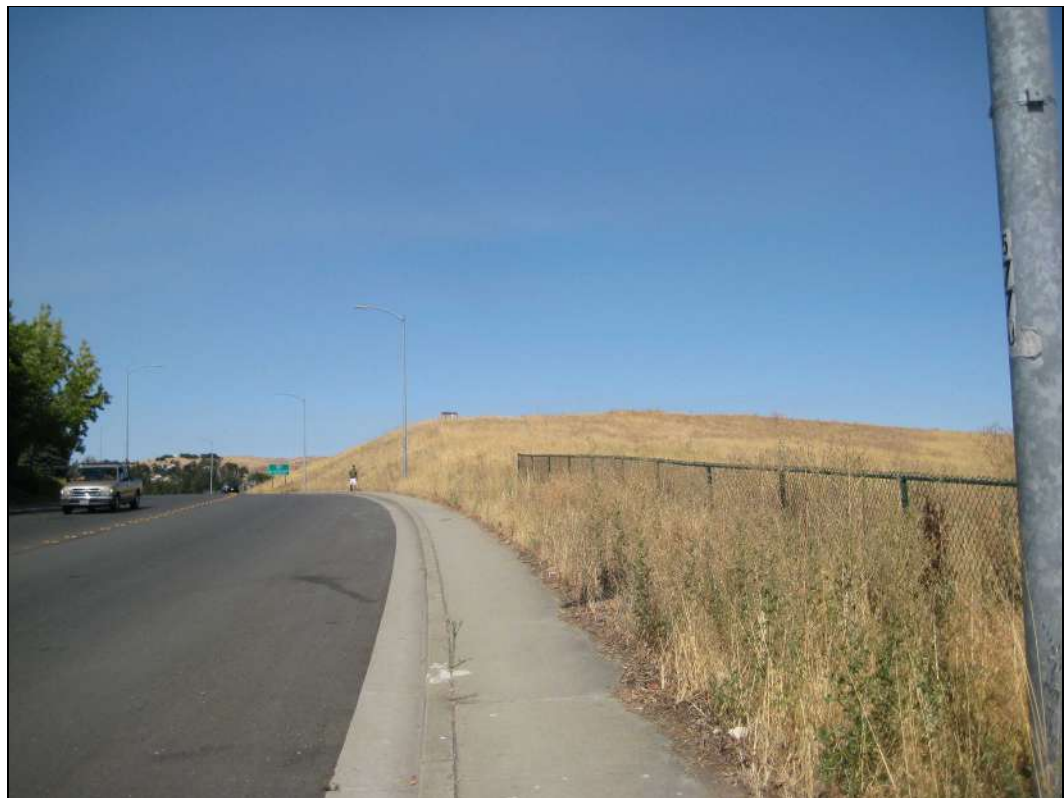
**Plate 4. View from Willow Avenue Looking East, Hercules, California (July 27, 2016)**  
***NOTE: Property is Shown RIGHT.***

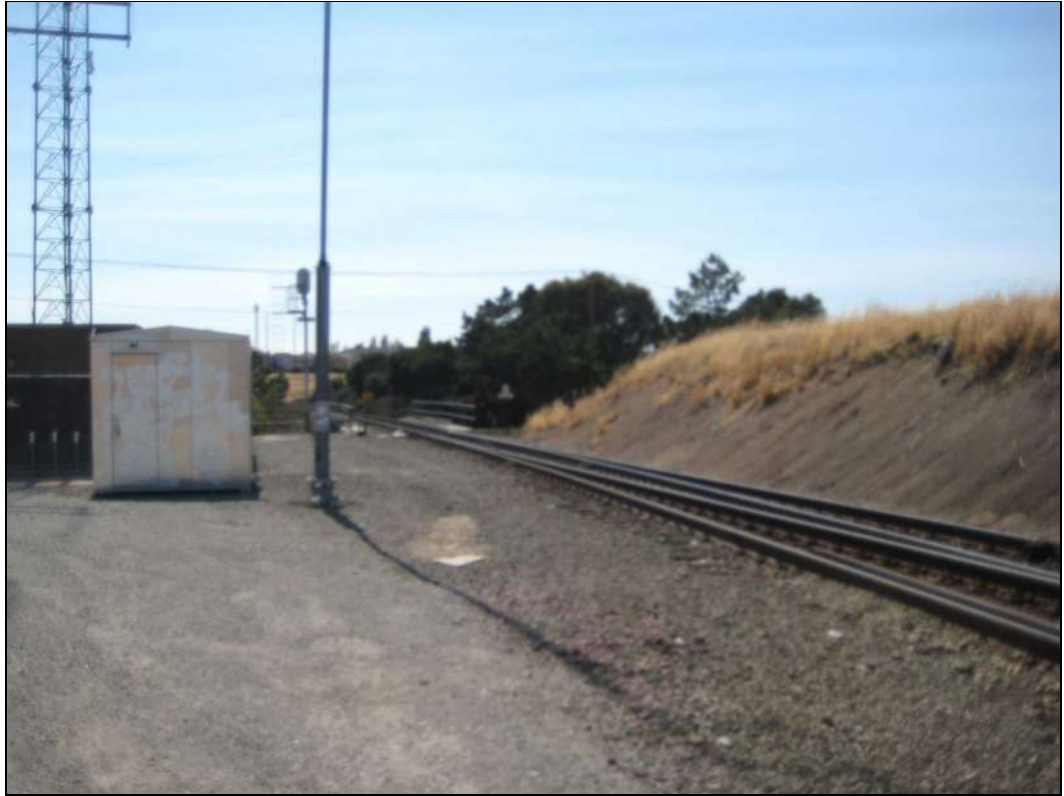
**Plate 5. View Looking West along the Atchison, Topeka & Santa Fe Railroad Tracks in Hercules, California** *NOTE: Palm Avenue Bridge in BACKGROUND.*

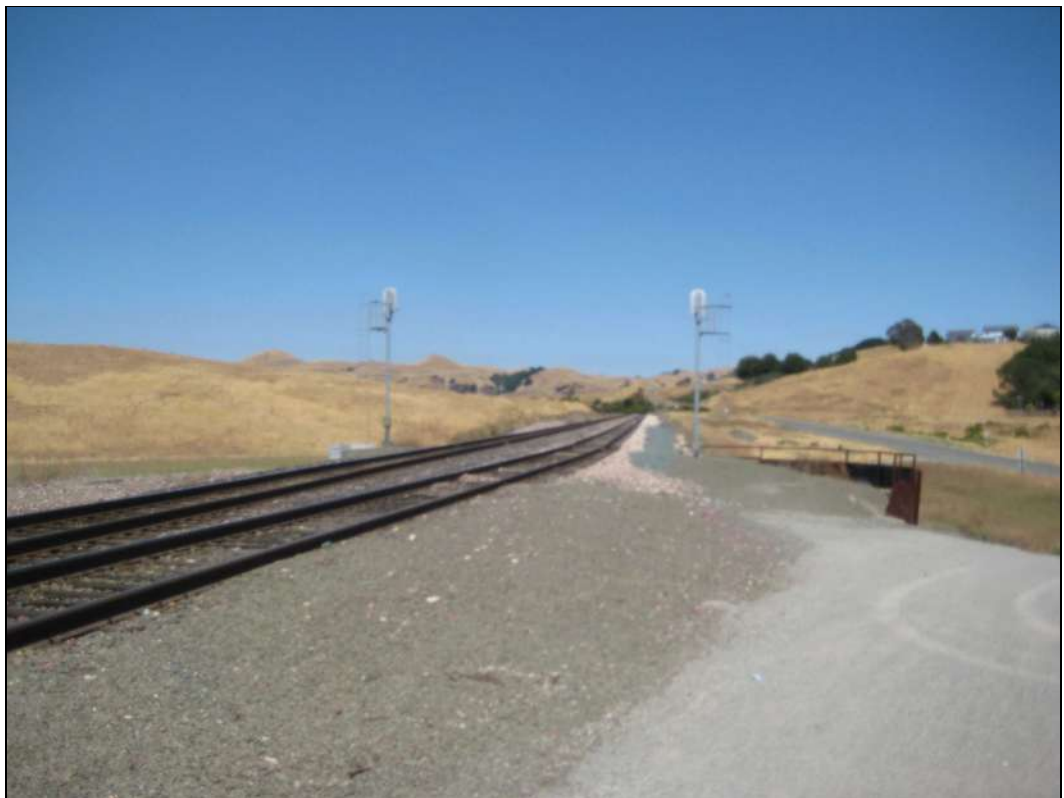
**Plate 6. View Looking East along the Atchison, Topeka & Santa Fe Railroad Tracks in Hercules, California (July 27, 2016)** *NOTE: Property is Shown LEFT.*

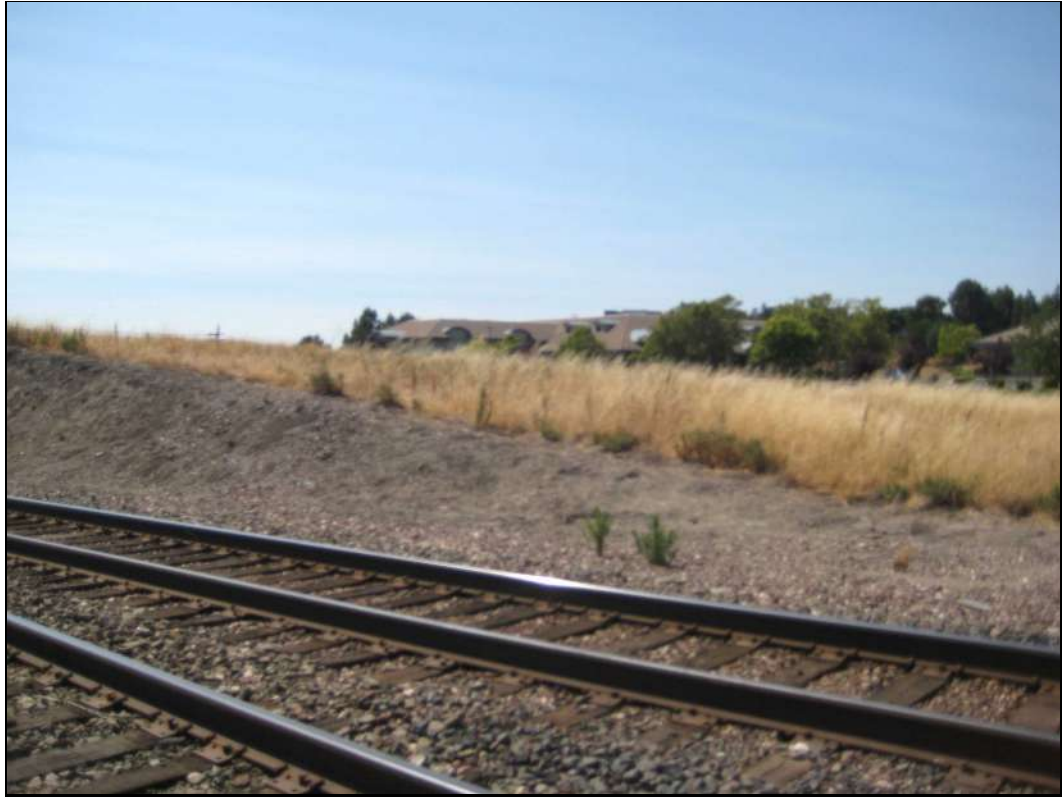
**Plate 7. View Looking West-Northwest across the Property and to the Adjoining Parcel, Valley Bible Church, Preschool & Daycare (1477 Willow Ave.), Hercules, California**

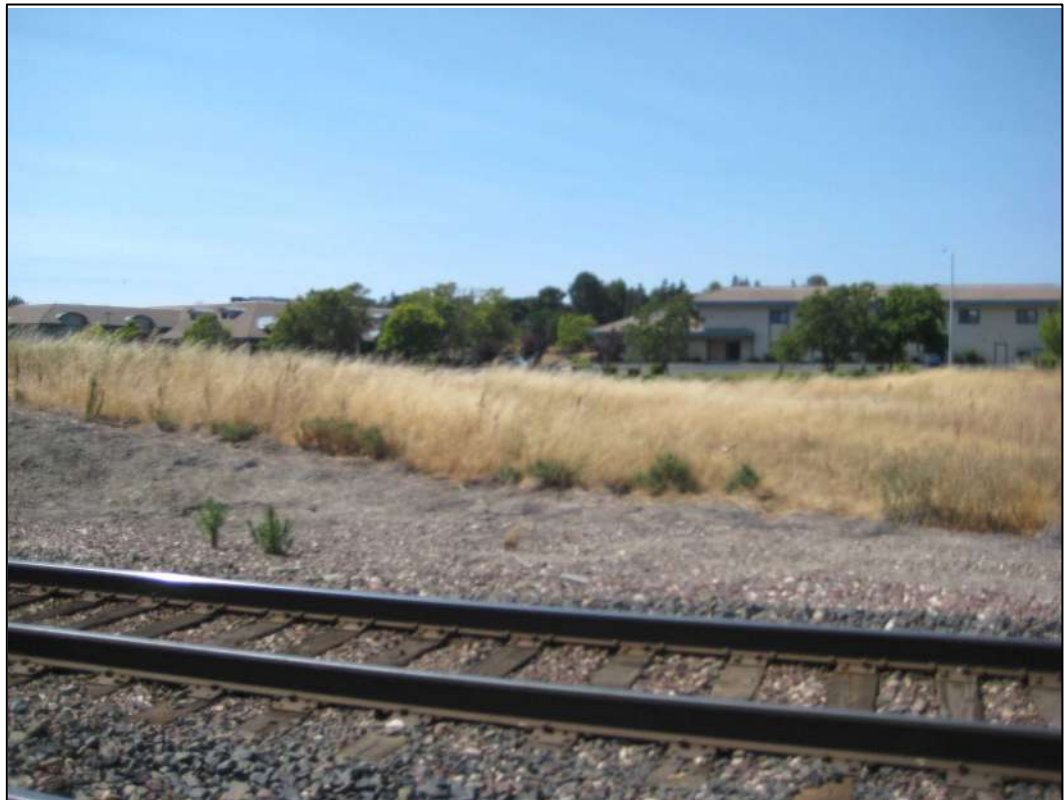
**Plate 8. View of the Property and Adjoining Preschool & Daycare at 1477 Willow Avenue, Hercules, California (July 27, 2016)**

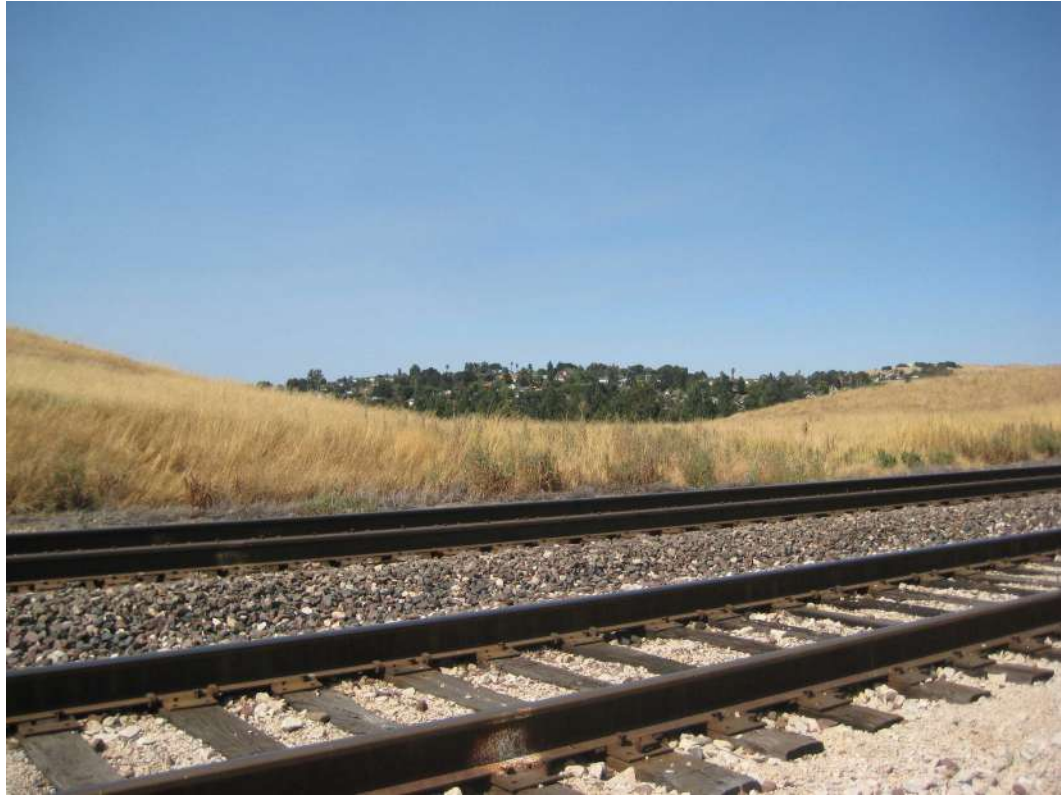
**Plate 9. View Looking Northeast across the Eastern Half of the Property**  
***NOTE: Windward Drive and Tradewind Place Neighborhood in BACKGROUND.***

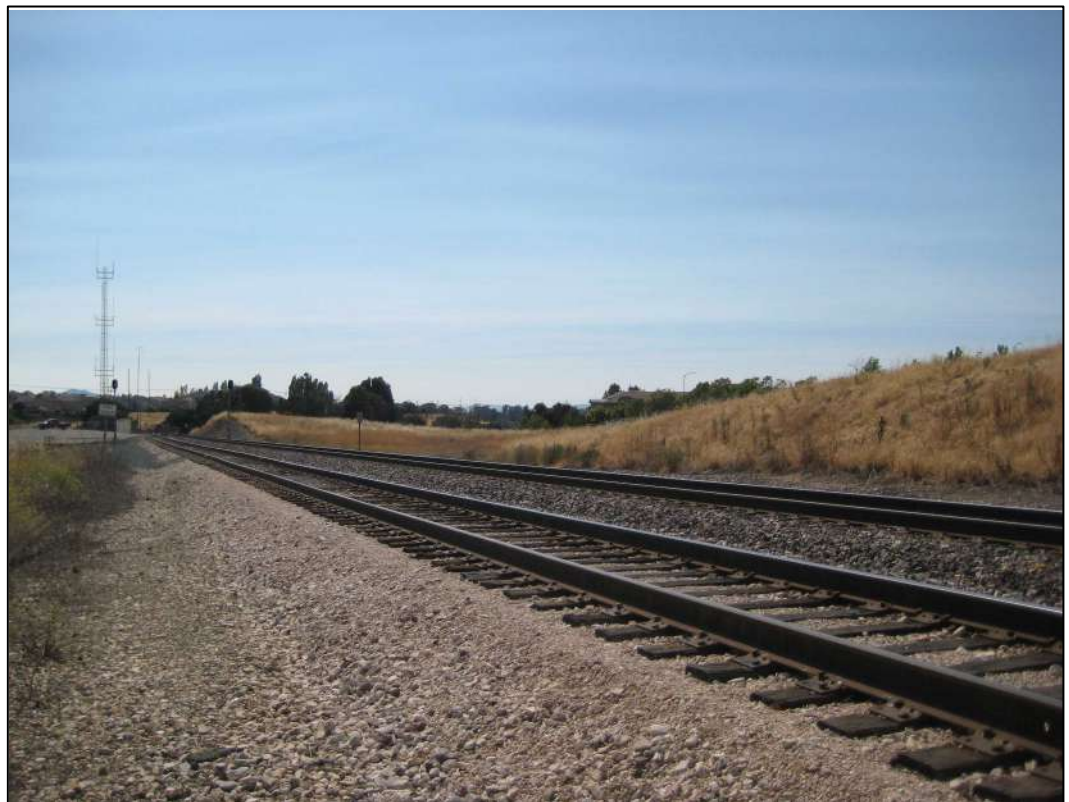
**Plate 10. View Looking West along the Southern Side of the Property in Hercules, California**  
***(July 27, 2016) NOTE: Atchison, Topeka & Santa Fe FOREGROUND.***
